# Annual Inspection Training

3S Americas, Inc.

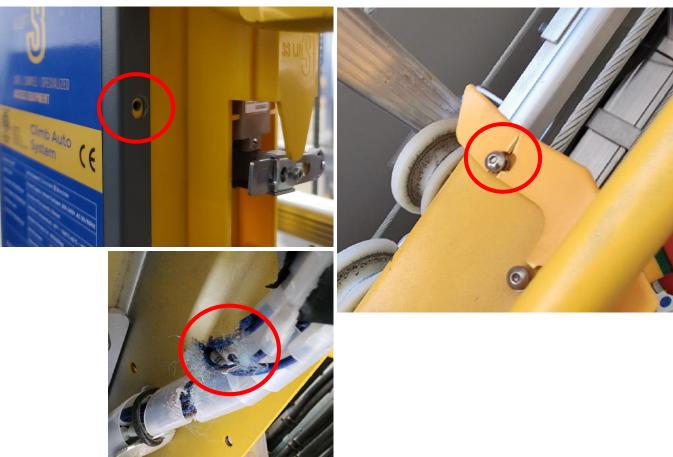
- Initial Down-Tower Inspection
  - Step 1: Inspect down-tower components for visible damage and missing parts
    - Handles
    - E-Stop
    - Plastic Covers
    - Broken Zip-Ties
    - Missing Screws
    - Warning Labels
    - Rodent Damage

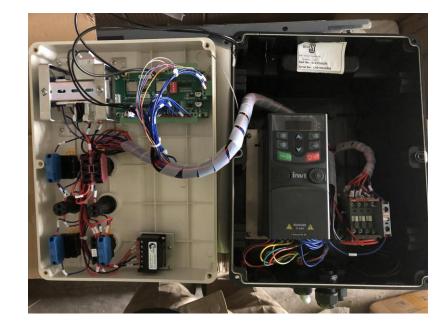
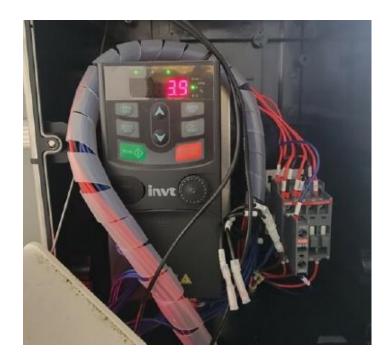
- In-Depth Down-Tower Inspection
  - Step 1: Remove Control Box Cover
    - Collect no-load current from VFD (3.5 4.5 is acceptable)
    - Collect running hours from VFD

The power must remain on to collect data from the VFD. Be careful not to contact any internal cables while the Control Box internals are exposed.

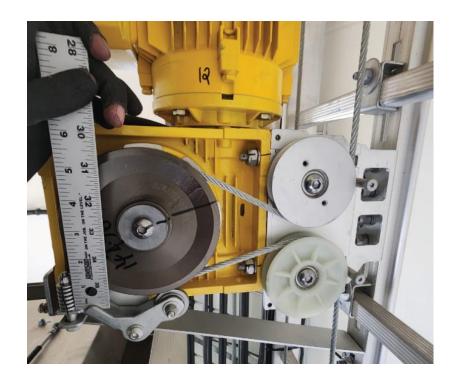
- In-Depth Down-Tower Inspection (continued)
  - Step 2: Remove Traction Unit Covers
    - Verify spring lengths are 25mm  $\pm$  2mm  $\frown$
    - Confirm proper routing of Wire Rope
    - Verify pulleys are in good condition

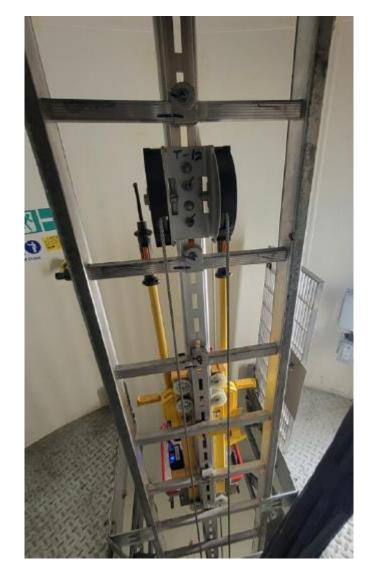
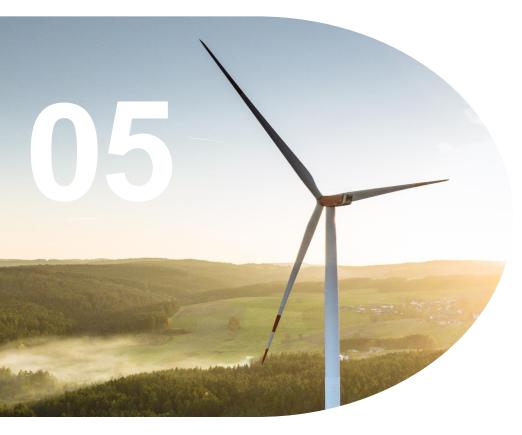
- Step 1: Inspect Up-Tower Components
  - Verify top limit flag is in the proper location <sup>C</sup>
  - Verify the Top Pulley is in good condition
  - Verify the Bumper is in good condition

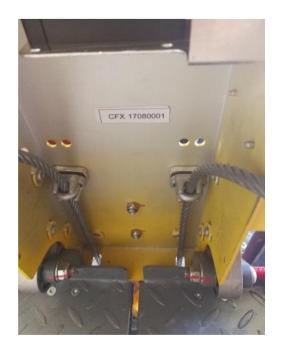
- Level 2 Re-Tension
  - Remove Slack from Wire Rope
  - Return Floating Pulley to Original Position
  - Level 2 Re-Tension Video
  - Additional Supplies Needed
